# REPLACEMENT OF BOWING TIMBER WALL MECHANICSVILLE, VA

ARMORMAX CASE STUDY

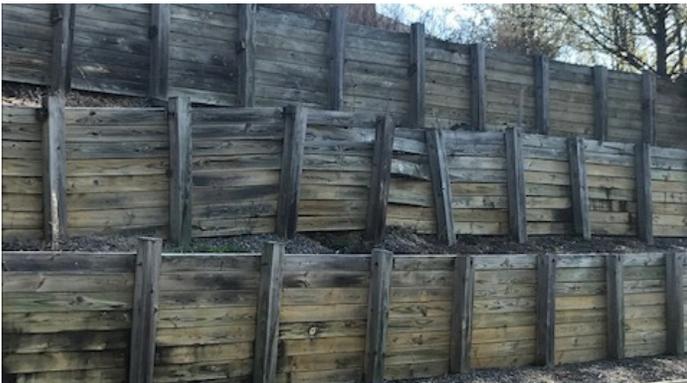
The client contacted ACF for assistance in finding a solution for a timber wall behind an office complex that was bowing out and causing an unsafe situation for anyone behind the building. As seen in the photos below, the wall was no longer considered stable needed to be fixed quickly and carefully.

Prior to installation - bowing wall

After careful consideration, Armormax was carefully chosen to replace the timber wall due to its lifespan (up to 75 years) and benefit of providing vegetation growth. The install required the timber wall be removed and surface of the slope to be smoothed out prior to the Armormax installation. In this specific install, it was discovered that a trench drain was required at the bottom of the slope due to water seepage. Following the installation of the high performance turf reinforcement mat, the system was secured in place with washer pins and Engineered Earth Anchors. The Engineered Earth Anchors were critical to the install as they help protect against hydraulic stresses and provide slope stabilization. Once the installation of the Armormax was complete, the product was covered with soil, seed and straw erosion control mats.

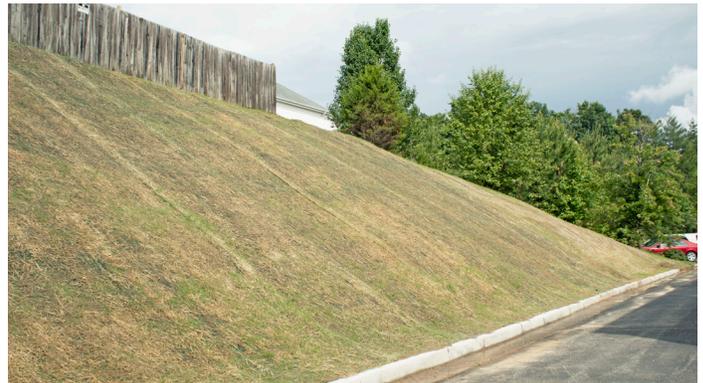
Post-installation with 3 weeks of growth  
(additional vegetative growth to follow)

The Armormax installation turned out wonderfully, with the vegetation quickly beginning to grow through the mats. A final installation picture showing 3 weeks of growth can be seen above. The client and surrounding tenants are thrilled with the result and are excited to see the final product when the vegetation has more opportunity to grow without the summer heat.

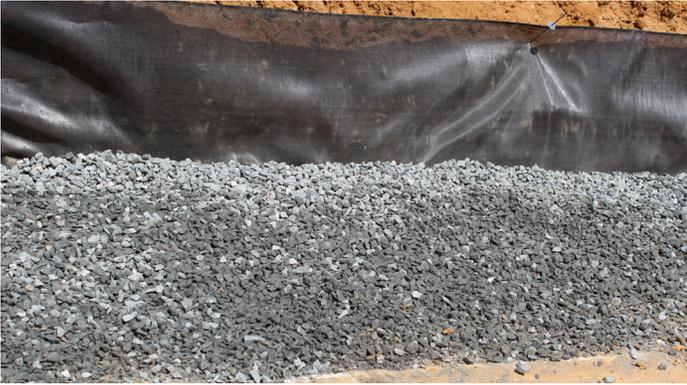
Installation of Trench Drain using \_\_\_ and \_\_\_ geosynthetic fabric to protect from seepage

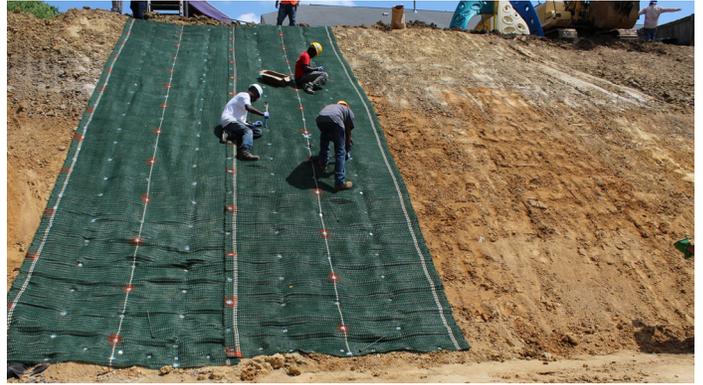
Beginning of Armormax install with Pyramat rolled down the hill and washer pins installed

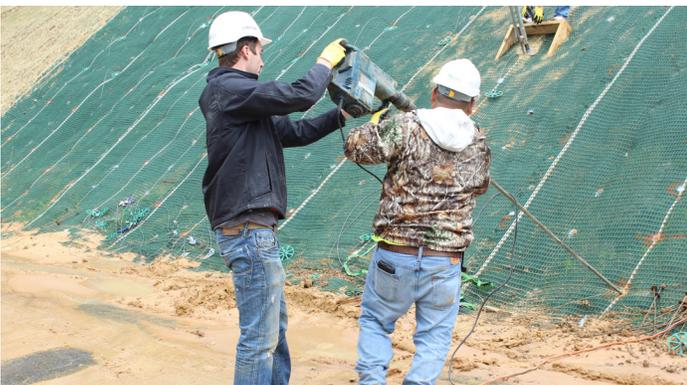
Engineered Earth Anchors installation using a power driver

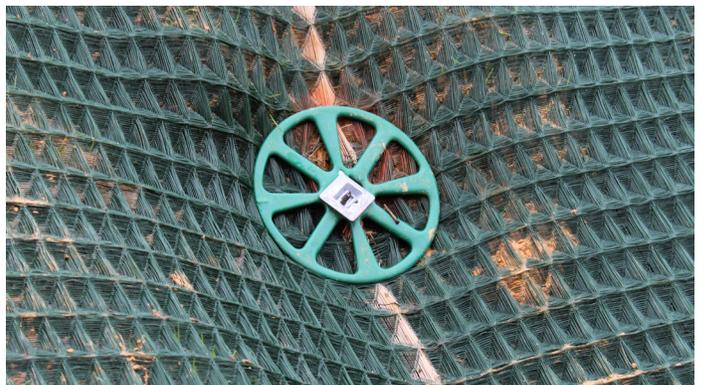
Complete Engineered Earth Anchors installation, with anchor flush against Pyramat

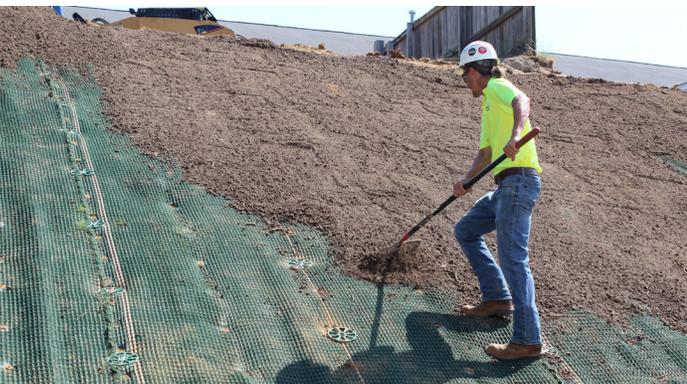
To promote vegetation, seed was placed beneath Armormax, beneath evenly spread soil coating and above soil coating

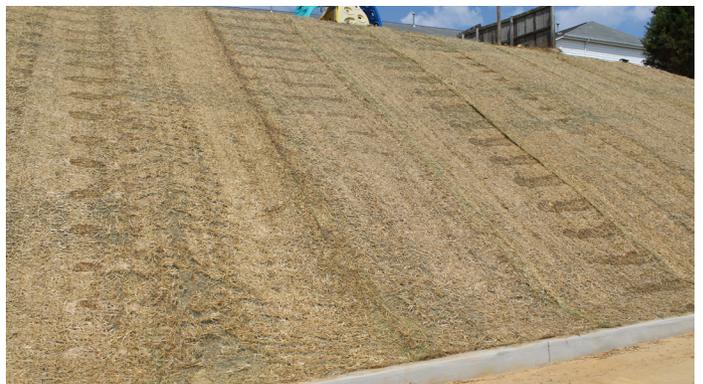
To protect the installation and new vegetation, a straw erosion control mat was installed
